HPLC Troubleshooting 2.0— How the HPLC Troubleshooting App Saves on Time and Frustration

Holger Franz; Thermo Fisher Scientific, Germering, Germany

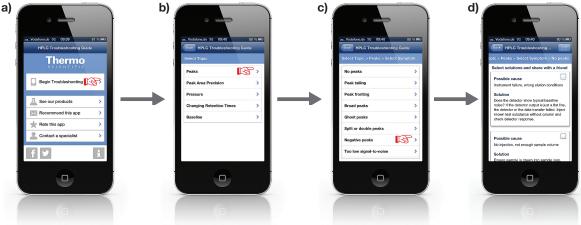
Figure 3. Generating probable cause using the Thermo Scientific HPLC Troubleshooting App.

- From the App's home screen, select "Begin troubleshooting" (Figure 3a).
- Because the issue is related to peaks, select "Peaks" (Figure 3b).
- Choose "Negative peaks" (Figure 3c).
- The App lists five "Possible cause / Solution" (Figure 3d), shown in Table 1.
